Archaeology from the Ice: Excavation Methods in a Frozen Hut

ANGELA MCGOWAN

Recent excavations in the snow and ice that fills much of the interior of Mawson's Hut at Cape Denison in Antarctica, had to overcome unusual problems. Relatively little has been published on excavation methods appropriate to polar conditions and the author, who is based at the Tasmanian Museum and Art Gallery in Hobart, had to develop appropriate techniques to meet the special conditions of the site. She was able to demonstrate that stratigraphic excavation procedures were quite possible, in spite of the difficulties. In this paper, it is argued that mechanical methods of removing ice and snow are preferable to melting these deposits either in situ or after removal in large blocks. However, the use of an ice axe to break up solid ice does cause some damage to contained artefacts and it seems likely that some combination of digging and carefully controlled melting may eventually prove to be the best approach.

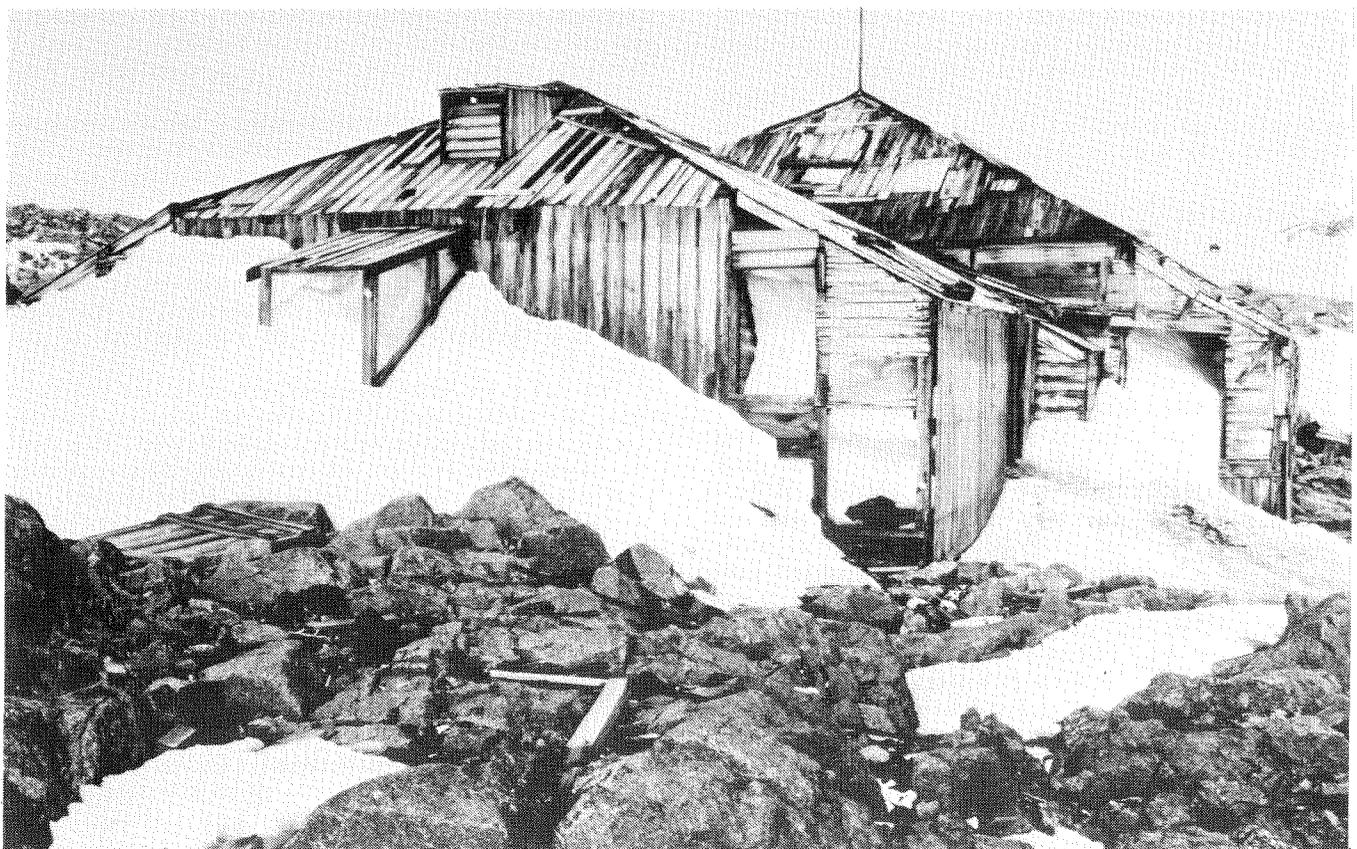
Fig. 2: Mawson's Hut at Cape Denison.

The largest and most important building at Cape Denison is the Main Hut, which was usually referred to by the A.A.E. as the 'Winter Quarters' and has been commonly known since as 'Mawson's Hut'. It is really two huts joined together to make a two-roomed hut for working and living (Fig. 2). Although entry into the Hut was fairly easy for visitors in the 1950s, since 1962 it has been full of snow and ice. This prevented visiting expeditions in the 1960s gaining access. However, in 1978 an Australian National Antarctic Research Expedition (ANARE) spent three weeks at the site, during which time they cleared the workshop room of snow and dug a tunnel into the living room which was found to have a large open space.¹² Subsequent expeditions have reopened this tunnel in order to inspect the interior. In 1985-86 this open space in the living room was found to have been greatly reduced by the influx of drift snow. The interior of the Hut is in total darkness and limited artificial lighting provided by generator or batteries allowed work to proceed. Summer temperatures inside the Hut are fairly constant, usually hovering around -4°C to -5°C .

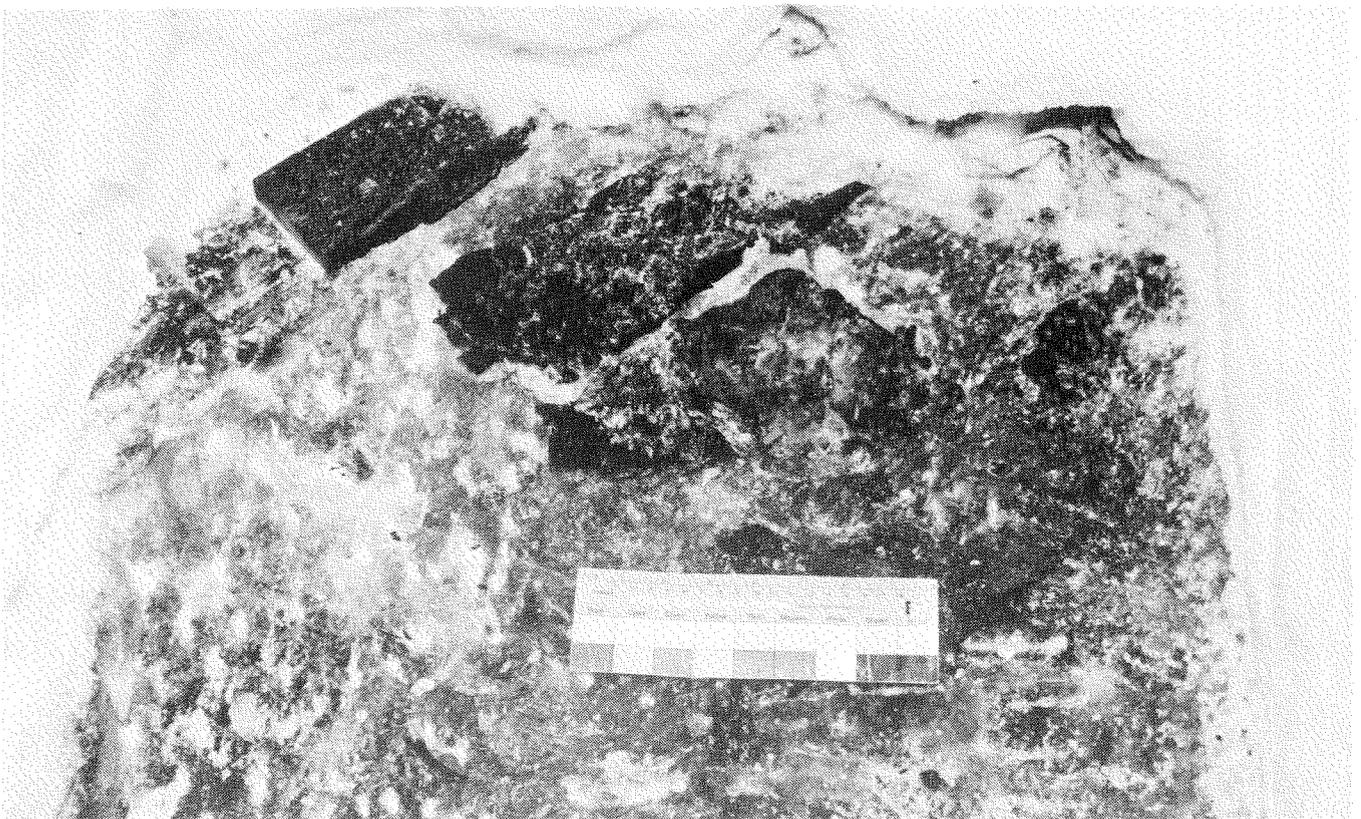
Fig. 3: Paper and wood in partly excavated solid ice. Scale of 20 cm.

Wind-drifted snow and the older corn snow were excavated fairly easily with a snow shovel and archaeologist's trowel. The solid water ice presented more of a challenge. Although small in volume compared to the amount of snow that was excavated, proportionally far more time and energy was needed. Water ice is rock hard and has to be shattered using considerable force with an ice axe. The ice shatters around the point of impact and the small chips can then be swept up with a stiff hearth brush and hand shovel. Eye protection should be worn while digging as small glass-like slivers of hard ice can fly upwards. Occasionally a small chisel was also found to be useful. Both ice axe and chisel had been recommended by the 1978 ANARE party.²¹ Because of the force required to dig through the ice, minor damage was suffered by some artefacts, especially the paper. Ice does not behave like soil or clay, which tends to peel away from buried objects. Rather it tends to fracture like glass. Removing objects from the ice caused considerable problems, and most pieces of paper and wood bear small nicks from the ice axe. The excavated snow and loose ice chips were carted away in a small snow sled, which was pushed along the access tunnel, and then dumped in a spoil heap outside the Hut entrance. Figure 3 shows paper and wood artefacts in a partially excavated layer of solid ice.

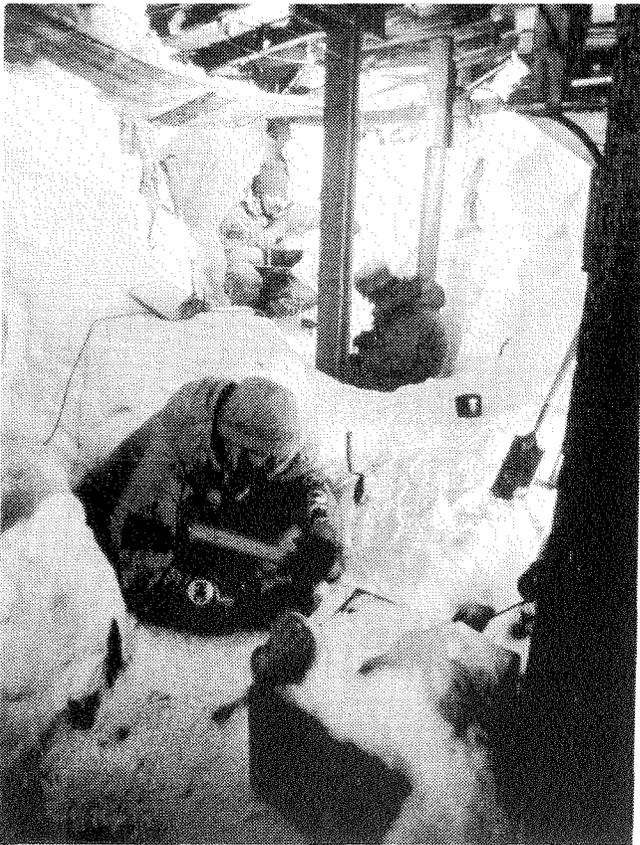
Fig. 4: Excavations in progress inside Mawson's Hut.

The actual area dimensions and locations of the pits were decided by the Project Blizzard architect, in order to accommodate the wide prop bases and to position the props beneath the broken beams. Each of the four pits was treated as an archaeological excavation trench and traditional excavation procedures were followed with each layer of snow or ice being removed separately. However, laying out the trenches and erecting datum lines above or across the sections proved a problem, as it was not possible to construct a grid inside the Hut. The major difficulty was ablation, the direct evaporation of snow, which made it impossible to anchor wooden stakes in the snow with any confidence that they would stay in place. Strings could be tied around some posts and beams but usually the other end could not be tied in the desired position. It was considered undesirable to damage the Hut by driving nails into the timbers or to excavate quantities of snow in order to anchor our strings. Indeed, the Antarctic Division had particularly asked us not to excavate more snow than necessary. Therefore, the four trenches were laid out and excavated without reference to an overall grid. Their positions were then related to various internal features of the Hut. For this purpose, the two northern queen-posts and the dining area partition were used as reference points and have been assumed to be square. The datum lines had to be erected in any convenient position and these were also related to the internal features. The depths of artefacts were measured and sections were drawn relative to

one of the datum lines, by the deft use of a carpenter's level and a plumb bob. Figure 4 shows excavations in progress.
