# 'The Hill': An Archaeological Survey of a Queensland House

PAM BLACKMAN

*Vernacular buildings can be interesting subjects for archaeological investigation as many such buildings are constructed in stages, or show signs of alteration or addition. Pam Blackman, a teacher from Ipswich, Queensland, reports on a survey of a vernacular building, a farmhouse constructed in the late nineteenth to early twentieth century in south-east Queensland. The house was built in three distinctive styles and the paper describes these styles, and discusses the sequence of construction and building methods. This building sequence suggests possible changes in the social and economic situation of the family concerned and changes in building fashion and technology over the construction period.*

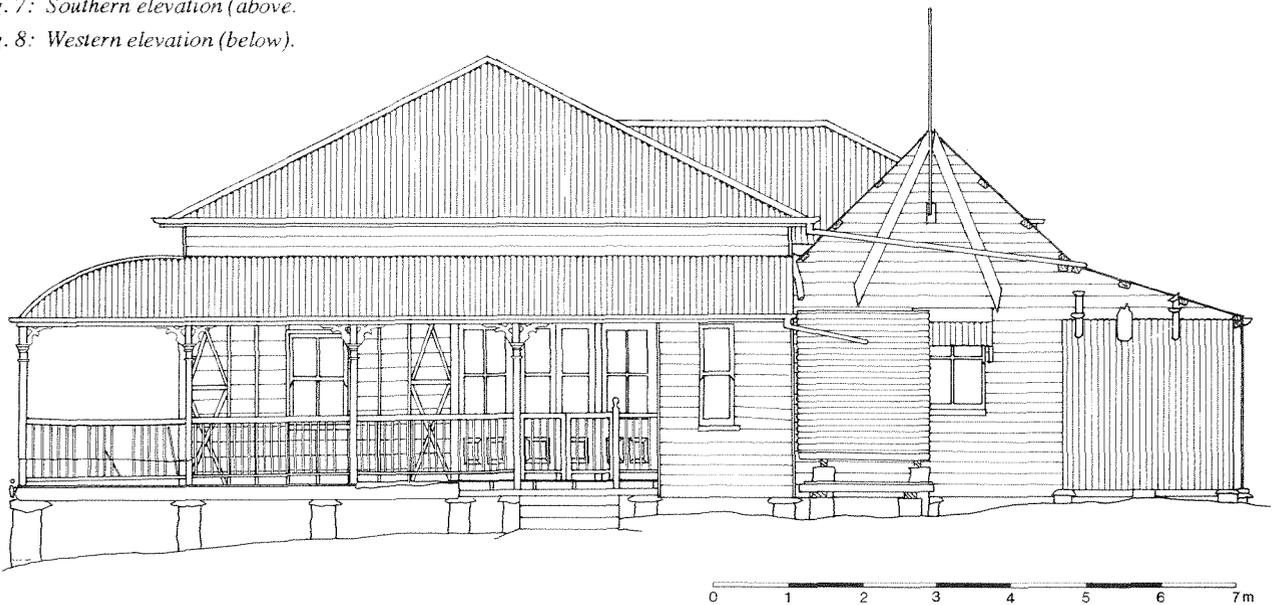
Fig. 8: Western elevation (below).

There were two vertically-sliding sash windows and one casement window. The corrugated iron of the window hood (Fig. 8) was attached with cup-shaped lead-headed nails, so belongs to either Stage 2 or 3. The roof is of corrugated galvanised iron. The northern side of the gable roof and the ridge cap have been attached with cup-

The survey discussed in this paper was limited to non-destructive methods. Measured drawings were made of the four elevations of the building, using a horizontal base-line string (Figs 5-8). A floor plan was prepared from measurements of the outer dimensions of the building and from room measurements. This floor plan was then used as the basis for the underfloor plan of stumps, bearers and joists (Figs 2 & 3). Measurements of the roof-pitch lengths allowed the calculation of roof heights and pitch angles. It was also possible to record how the roof of Stage 3 was connected to the Stage 1 building, and to investigate the use of different types of roofing nails. Access to the ceiling was restricted to a 30 cm-wide ventilation hole in Room 7 (Stage 2) and although this allowed the observation of some of the techniques used for joining Stages 2 and 3, little measurement was possible. The walls of Stage 2 had been extended upwards during the construction of Stage 3, so that the view within the roof space was virtually restricted to the Stage 2 area. An approximation of the layout of the roof was made but no accurate recording could be done. There was no means of observing the internal junction of Stages 1 and 3 and no possible access to the roof space of Stage 1.

From the underfloor plan and the elevation drawings (Figs 3 & 5–8), three phases of construction can be identified. On the underfloor plan (Fig. 3), the section built with bush timber is obviously of a different era from those sections built with sawn timber. The contrast in building styles between this section containing Rooms 1, 2 and 3 and the rest of the building can be seen from Figures 7 and 8. The use of bush timber bearers and joists and the weatherboard construction with gable roof and skillion would suggest that this section was constructed first.

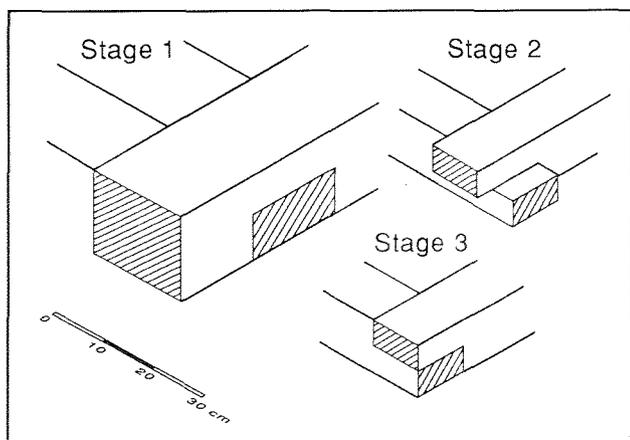
Fig. 11: Isometric views of the corner joints of bearers.

Stage 1 of the house was built on low stumps, the bearers and joists being of bush timber. Where the bearers could be seen, they had been squared off and a section had been removed where each bearer rested on a stump. The corner joints of the bearers were halved joints with squared-off protrusions beyond the joint (Fig. 11). The floor-boards were of hardwood.

There were some refinements in techniques over the fifteen year period, as can be shown in changes in bearer corner joints. The Stage 1 joint shown in Figure 11 was replaced in Stage 3 by a simple halved joint. Corner posts were not used at all in Stage 3 but the studs were still mortised into the bearers and not into a bottom wall plate.

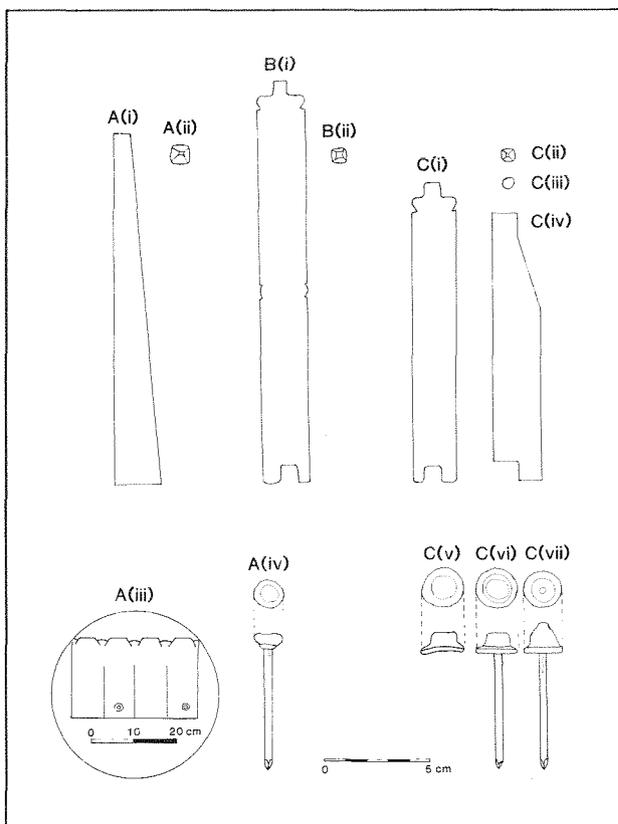
Fig. 12: Some materials used in the building.

Stage 1: A (i) Section of weatherboard. A (ii) Nailhead, from wall. A (iii) Ridge cap. A (iv) Lead-headed nail.

Stage 2: B (i) Section of tongue-and-groove board. B (ii) Nailhead, flooring nail.

Stage 3: C (i) Section of tongue-and-groove board. C (ii) Nailhead, from wall. C (iii) Nailhead, flooring nail. C (iv) Section of chamferboard. C (v) Lead-headed nail. C (vi) Modern lead-headed nail: used. C (vii) Modern lead-headed nail: unused.

late 1887.<sup>3</sup> These nails are illustrated in Figure 12. This evidence gives a probable date of 1880–1887. From historical evidence, Amelia Patrick went to the house as a bride in June 1887.<sup>4</sup> Until 1885, Amelia's future husband was officially residing at Mount Hallen, some 25 km distant, as part of a land selection agreement.<sup>5</sup> This gives a probable construction date of 1885–1887.

The wall studs were mortised into the bearers, as were the 100 x 100 mm corner posts. They were clad with weatherboards attached with rose-headed nails (Fig. 12). The walls were originally unlined, as the ceiling may also have been. However, the ceiling is now lined with 140 mm-wide tongue-and-groove boards, perhaps from a later period, and the walls are lined with 'Masonite', definitely from a later era.

shaped lead-headed nails, while the southern side and the skillion roof have been attached with the older small lead-headed nails. The ridge cap was made from corrugated iron, stamped or punched to make a pattern that allowed it to be bent over the roof ridge (Fig. 12).

The building style was Queenslander,<sup>8</sup> with an exposed framework on the outside of the core and horizontal tongue-and-groove cladding on the inside of the framework. Figure 12 shows a section of the cladding. The wall studs were mortised into the bearers and the upper wall plate, with a diamond pattern of bracing in a panel at each end of three of the four walls. There are cut-in diagonal braces on the remaining southern wall. The windows were of vertically-sliding sash type.

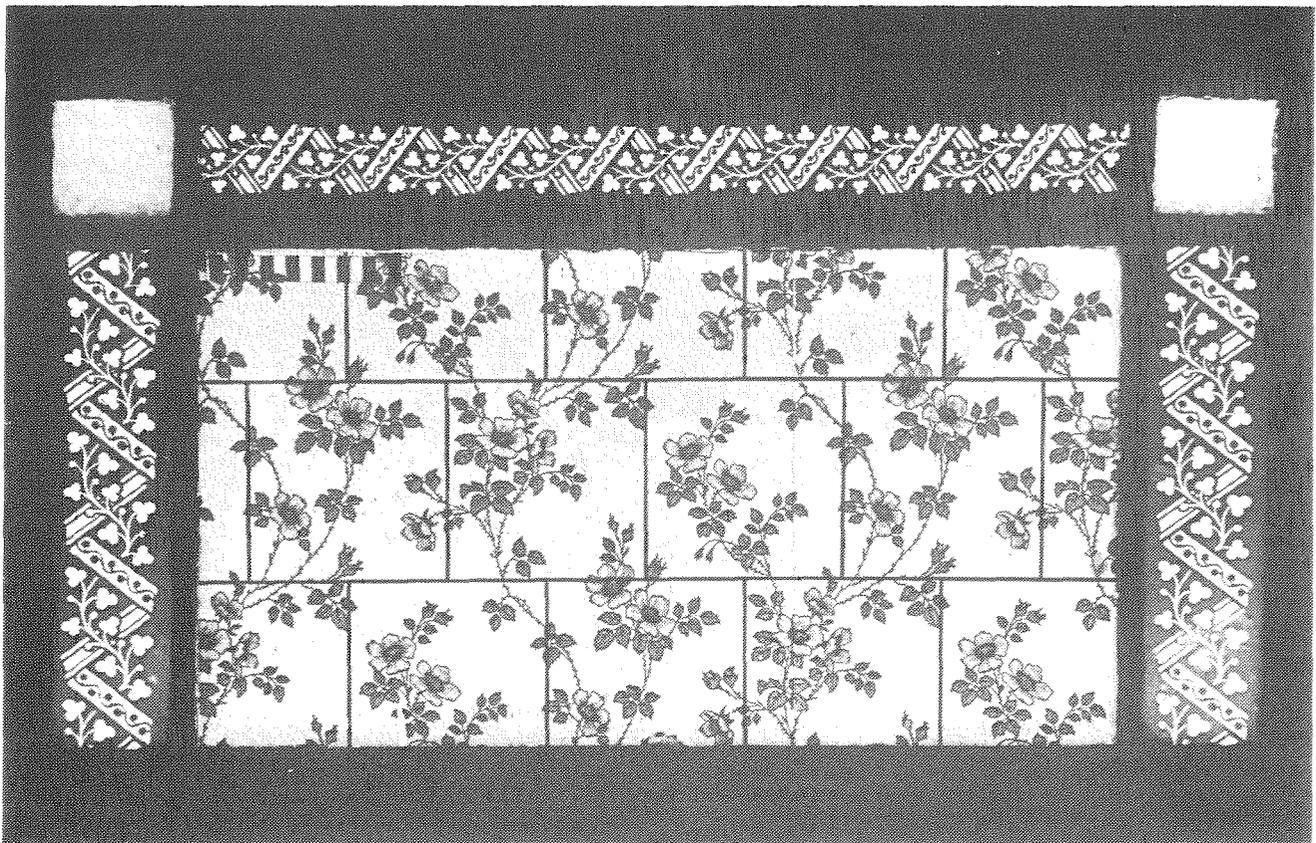
Fig. 13: Window decorated with flashed glass and transfer design. Scale interval 1 cm.

windows added a decorative touch, with red flashed glass forming a border on three sides of each of the three main panes of glass, which were covered with a transfer design, collectively providing a theme of shamrocks and roses (Fig. 13).
