Katherine Mansfield's Birthplace: Archaeological Investigation for a Late-Victorian House Museum

KEVIN JONES

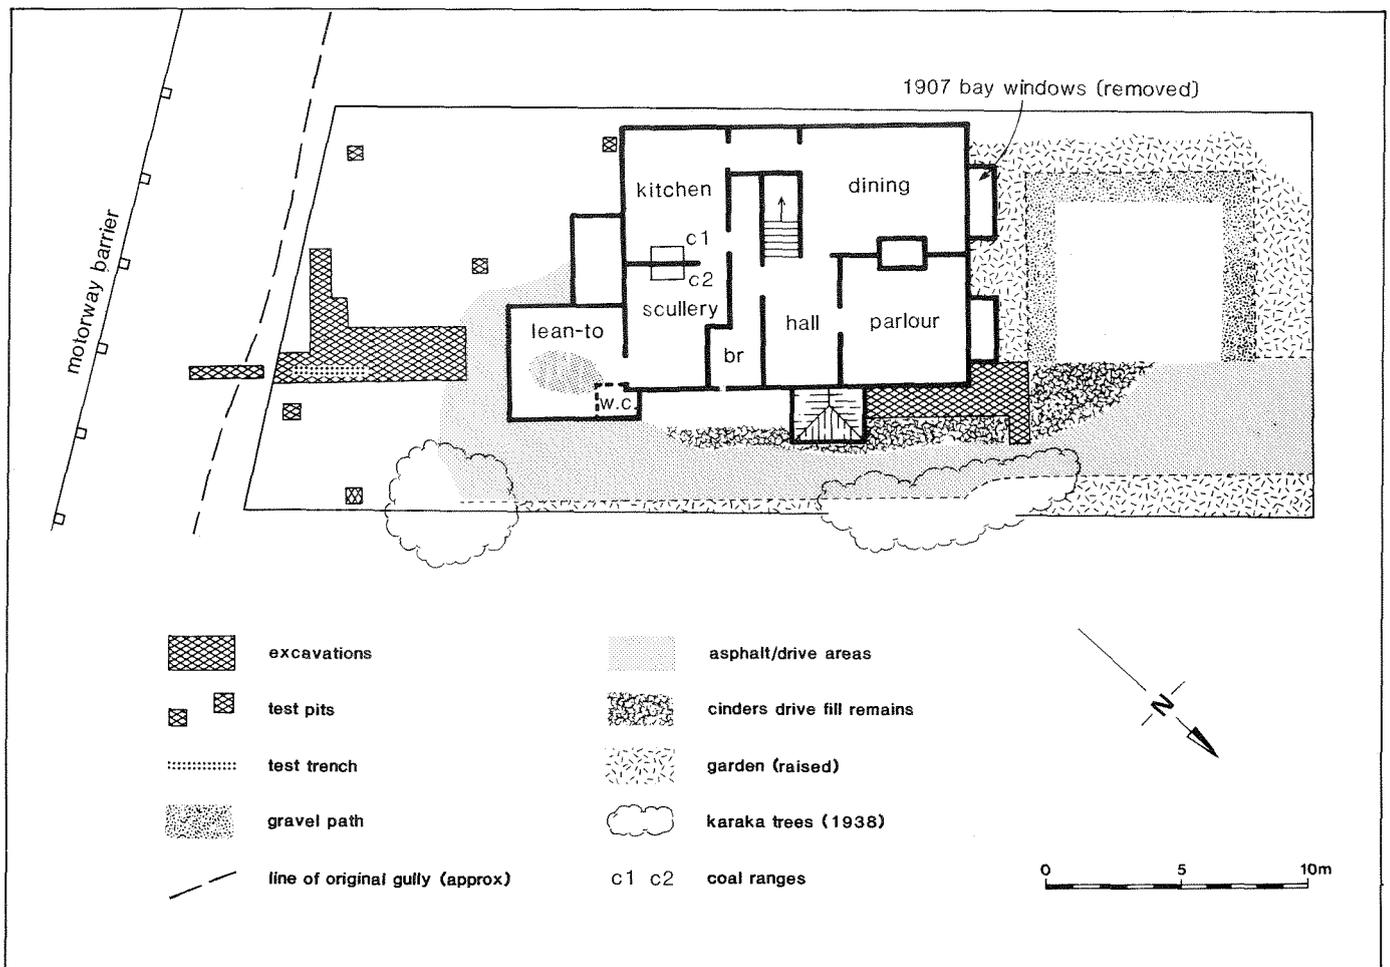
Fig. 1: Plan of section at 25 Tinakori Road showing the interior layout of the ground floor in its 1907 form. The bay windows were added at this period and were removed in the course of the recent restoration. The floor of the lean-to was at ground level, hence the asphalted floor.

In its original form the house comprised two storeys, with bedrooms upstairs (not shown in figures). Downstairs, there was a parlour and sitting or dining room in the front (the northwestern segment) facing towards Tinakori Road (Fig. 1). A complicated set of passageways and doors gave access from the sitting room and the entrance hallway to the rear of the ground floor. Here there was a tiny bathroom (on the northeastern wall) and a scullery and kitchen or family room adjacent to each other. The scullery opened on to a lean-to. This had an asphalted earthen floor, some 60 cm beneath the level of the floorboards of the rest of the house. The lean-to contained the single flush toilet. As noted, the section slopes to the rear and drainage to the roadline was marginal.

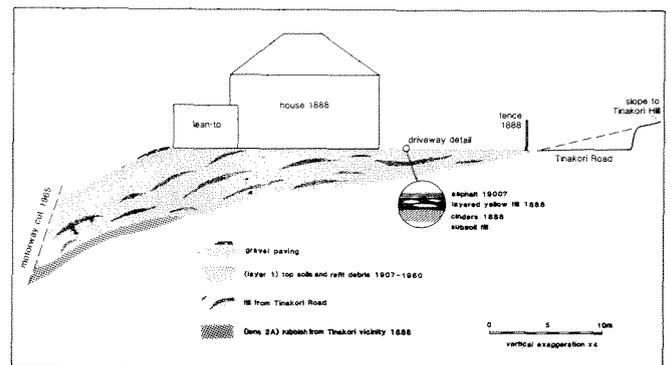
Fig. 2: Schematic stratigraphy of the site. The modern motorway was formed in the original gully at the rear of the house. Stratigraphy is vertically exaggerated, not the house.

Figure 2 shows the schematic stratigraphy. This was comprised of topsoil at the rear of the section (Layer-1), and a fine layering of driveway fills (although no signs of stripping) at the front and northern side of the section. Underlying the whole of the property was a subsoil fill of yellow-brown silty clay and crushed stone. The fill was probably from concurrent widening of the adjacent road cutting. The crushing of the stone arises from faultline activity and is common in Wellington hill soils. The general chronology of the various layers and surfaces of the property as they were in use over 100 years is shown in Table 1.

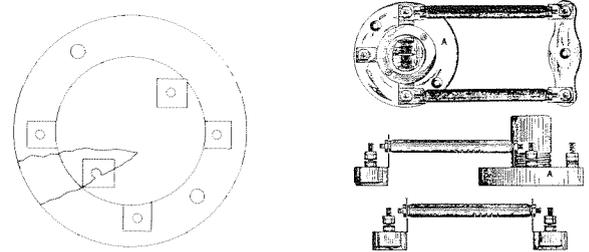
Cooke's Protector 1890. Telephone lightning arrester

underside of circular base "A" showing fragment see "Telephony" by A.V.Abbott, 1904

Fig. 3: Reconstruction of the ceramic base of the Cooke's lightning arrester. The fragment in dark tone was recovered in the excavation.

The rear yard topsoil (above the layer 2 fill) nevertheless contained house and building materials, including a large volume of used nails, lead-head nails, drainage pipes, and ceramic tiles, presumed to be from the original service areas reworked in 1909 and 1940. The building materials in this layer may be securely attributed to the house in its original 1888 form. They include the 'Cook's' telephone/lightning arrester (Fig. 3).⁸

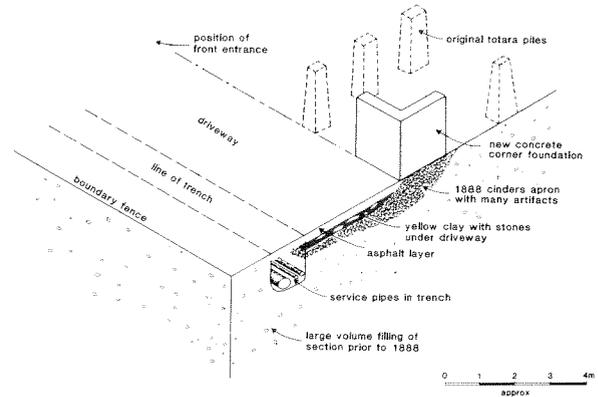
Fig. 4: Schematic isometric drawing of the relationship between front drive stratigraphy and the house. (The reinforced concrete corner foundation, installed during conservation work, is embedded at a lower level than shown).

The bulk of the layer of cinder fill on the front drive immediately pre-dates the building of the house (Fig.4). It extends slightly under the baseboards, and may have been an apron of fill placed in the course of constructing the house. Fill for driveways and compacting of surfaces generally was made up from household fireplace ash and cinders.⁹ This could have been stockpiled with other domestic rubbish in the near-city neighbourhood and laid on the drive to some depth. Household rubbish also occurs in the yellow layered fill which occurs above the cinders and below the asphalt layer.

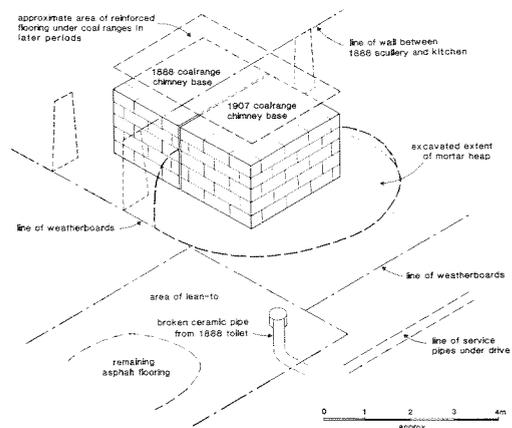
Fig. 5: Isometric drawing of the eastern corner of the house, showing details of the under-floor area of the lean-to-scullery-kitchen.

Further excavation or inspections were carried out when major structural strengthening was undertaken (Fig. 5). This offered an opportunity to inspect significant sections at the four corners of the house, where reinforced concrete foundations were employed. The planned work also involved disturbance to structures under the house.

The removal of base boards on the east corner of the main house and on the lean-to opened up an area under the lean-to that earlier could not be seen clearly. The isometric plan of this corner of the house (Fig. 5) shows a ceramic drain pipe broken at the surface and leading away from the northeastern side of the lean-to. The pipe turns up at its southwestern end. This is probably the vent pipe for the original gullytrap, connected outside the asphalt-paved lean-to.

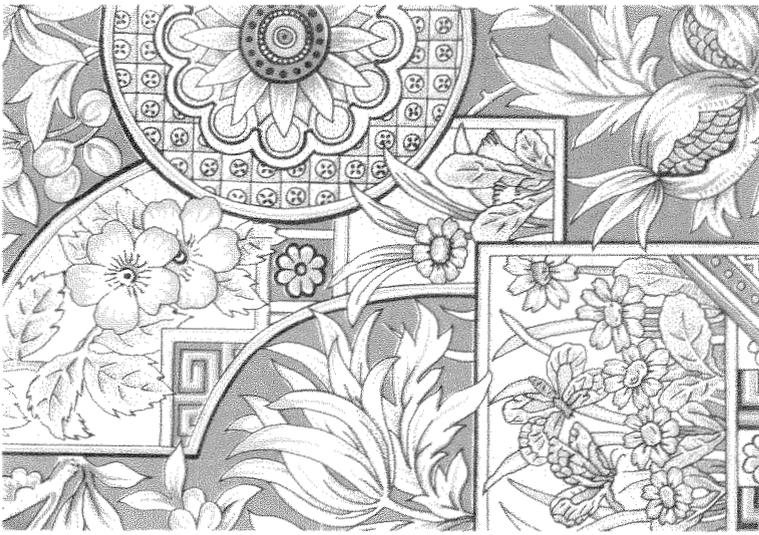
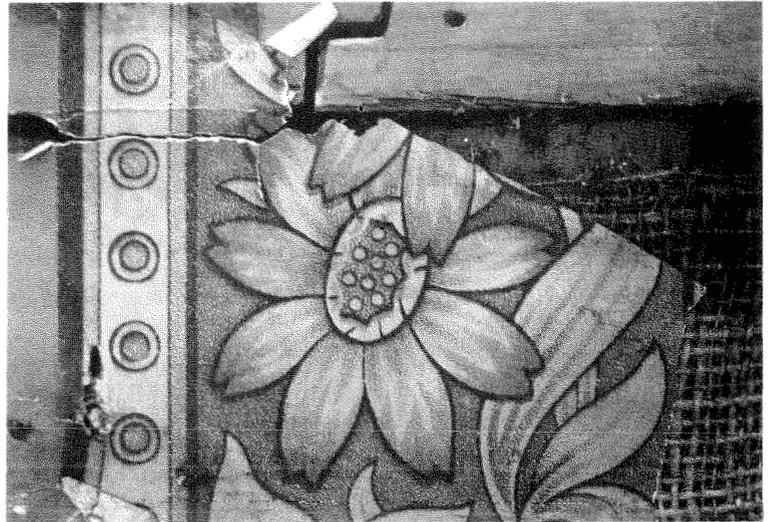
Fig. 6: Wallpaper: (a) reconstructed from original papers found mainly under architraves but also from excavations; (b) original fragments showing scrim. The designs show a strong Japanese influence (see also Fig. 7).

Many fragments of wallpaper were found (Fig. 6). These occurred in some large pieces on the surface in the vicinity of the chimney base, and also buried in the chimney debris on the east of the base. These were sometimes associated with pieces of 1940s newspaper, i.e., contemporaneous with the rebuilding of that date. A number of pieces were comprised of several layers of wallpaper, some of which came from beneath architraves since they form the edge of the paper. This was a style of papering found throughout the house in the architectural inspections. However, the prime evidence for wall coverings came from architectural inspections of areas behind skirtings, cornices, and jambs.

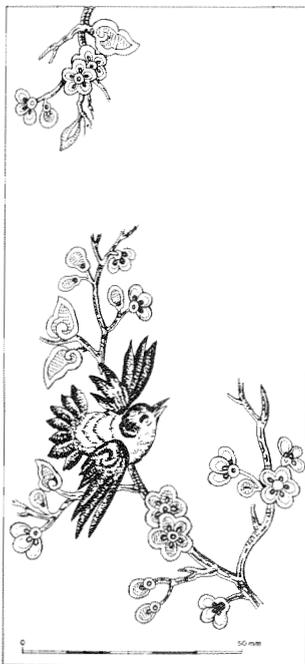
Fig. 7: Brown underglaze Japanese blossom and bird mug. Separate fragments were recovered from the base lenses of the rear yard fill, and from the driveway fill.

The cinder layer was one of the most artefact-rich layers on the site. Material from it matches the lowest lenses under the fill in the rear yard. Two fitting parts of one important artefact, the Japanese-style cherry blossom with bird mug, occurred in the driveway cinders and the rear yard fill.

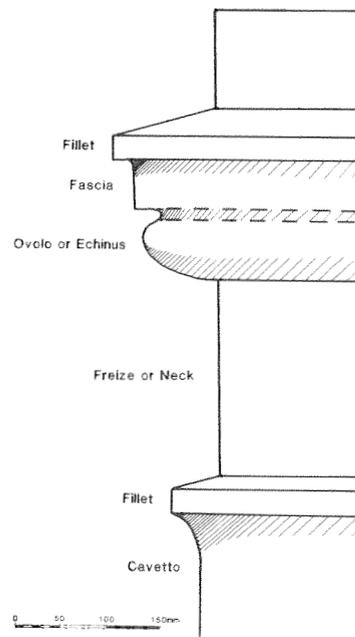
Fig. 8: Chimney head moulding detail, reconstructed by project architect, Jim Beard, from material used as hard fill in the front steps, and from pre-1948 photographs of the house.

- Maroon-banded with gilt dinner-set pieces: fragment of a cup in rear yard rubbish lenses (i.e., layer 2 lens A), with the bulk in driveway cinders fill near the house;
- ‘Hampden’ plate from driveway cinders;
- Child’s tea-set pieces, from the rear yard rubbish lenses and driveway cinders;
- The original chimney-head mouldings (Fig. 8) found in the hard fill of the front steps, placed there during the 1940s refurbishment.
