The history, archaeology and material culture of 105 Radar Station, Cox Peninsula, Northern Territory

TIM OWEN and SHELLEY JAMES

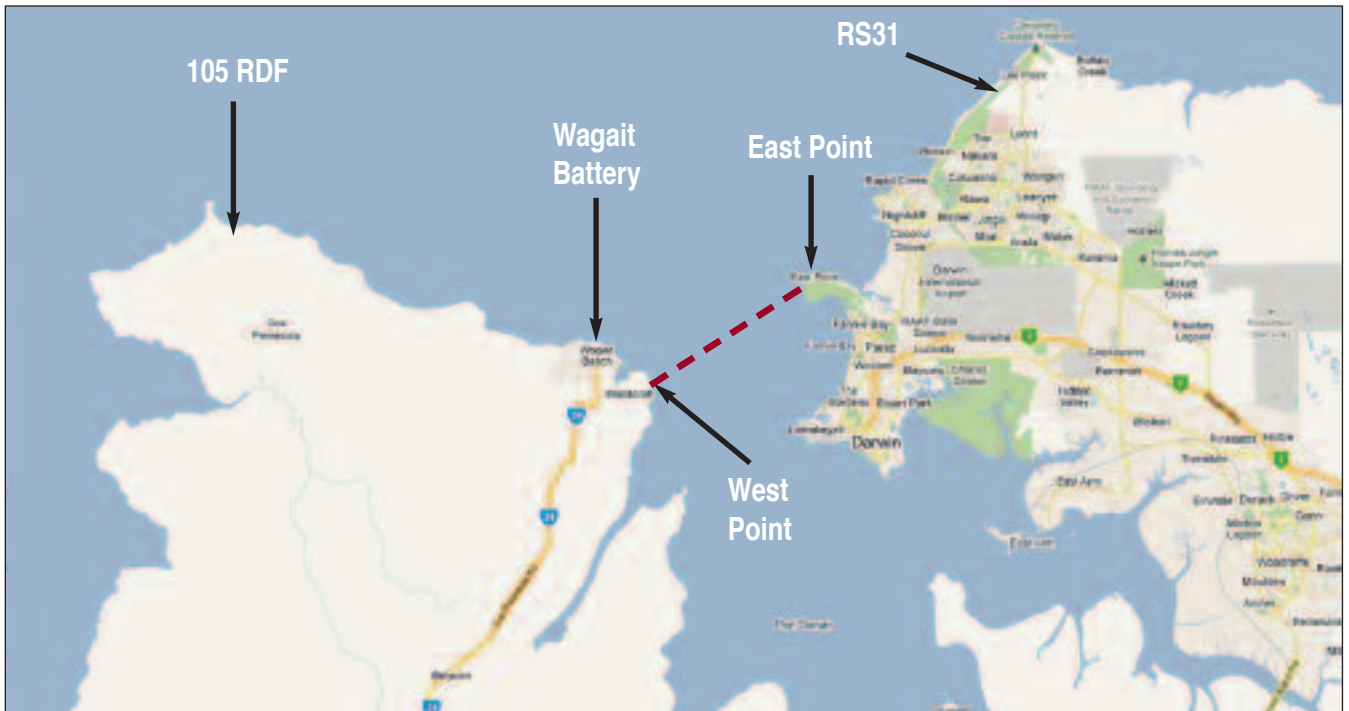
Figure 1: Key WWII Defences on the Cox Peninsula, East Point and RS31. Red line is the submarine net extending between East and West point (Image source: Google Maps).

The Cox Peninsula is located to the west of Darwin, approximately six kilometres across the bay. Three defensive positions were established on the peninsula, two obvious and one in some secrecy (Figure 1).

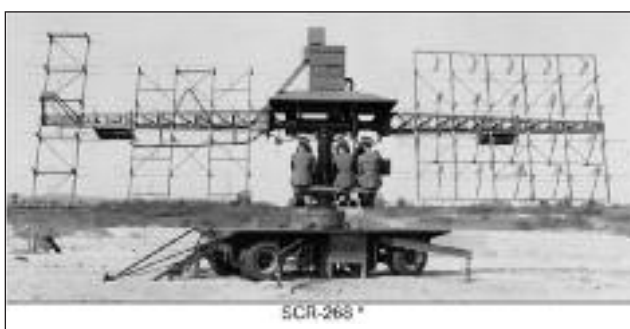
Figure 2: Exposed operators sat on a SCR 268 (NB this photograph is not of 105 Radar Station) (www.vectorsite.net).

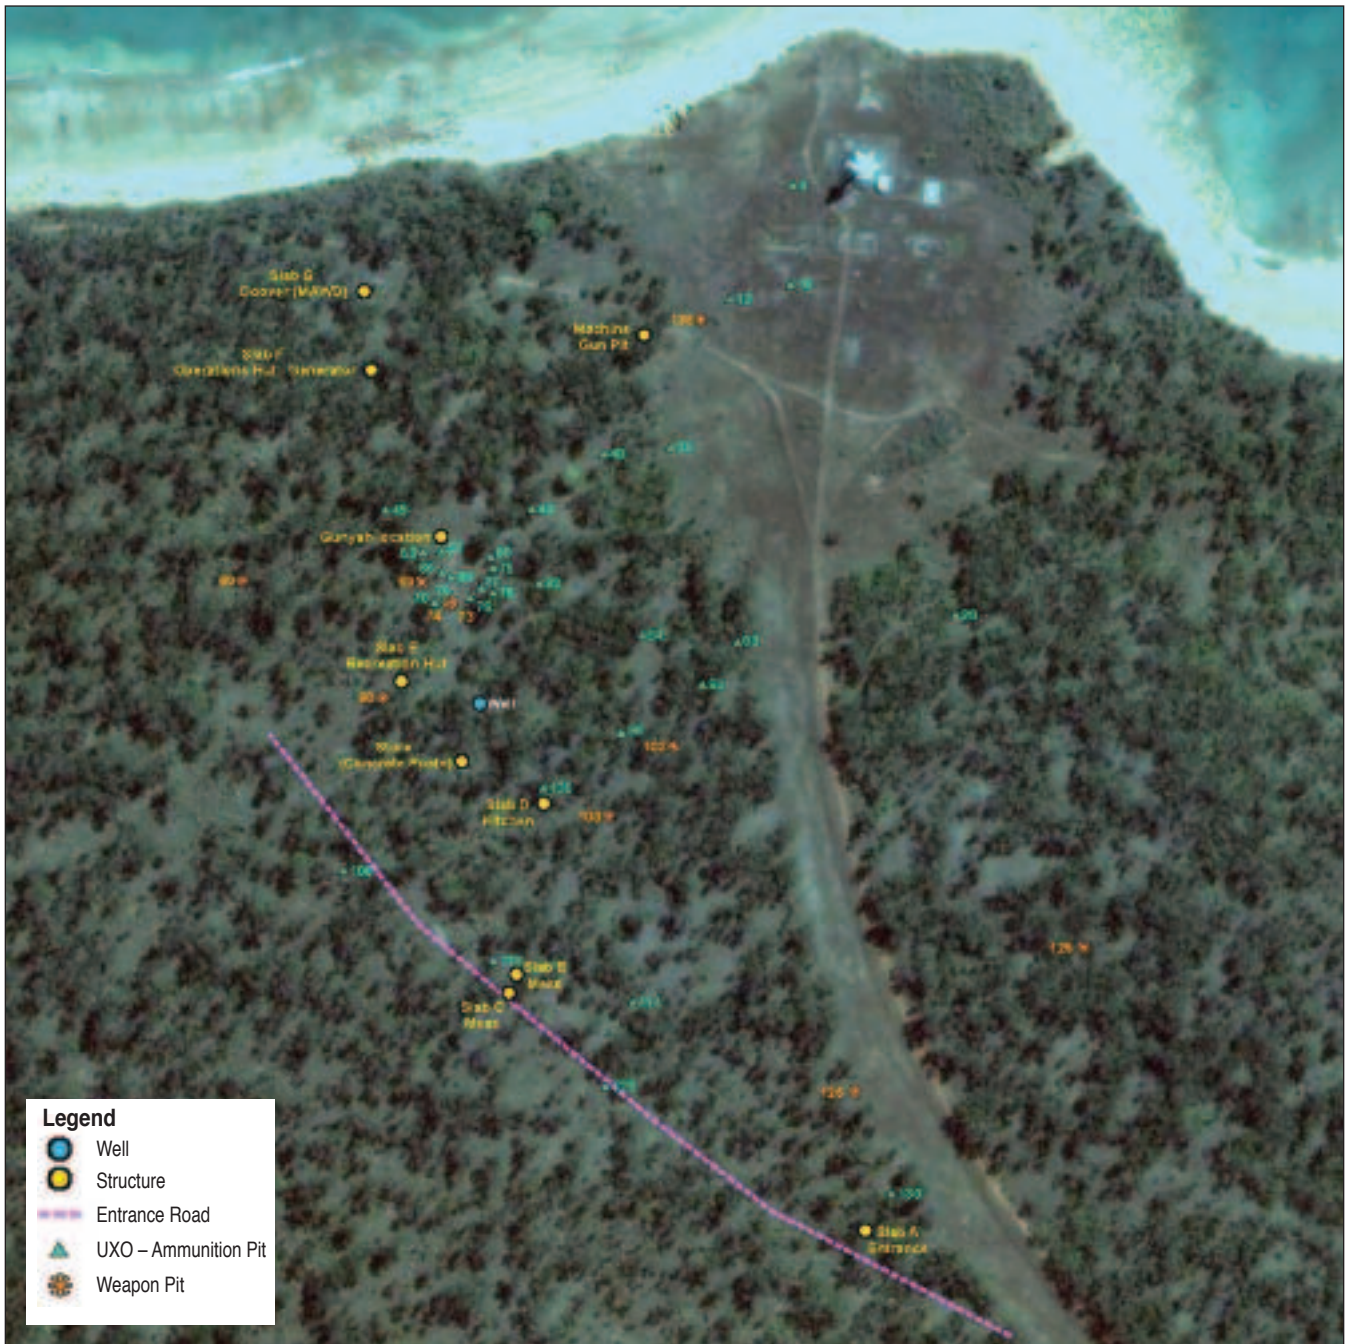
Figure 4: The layout of 105 RDF, as recorded in 2010, showing structures and ordnance (Owen and James 2010b:Figure 5).

Hobbins' mud-map (Figure 3) was used as the initial basis for interpretation of the archaeological remains. It was immediately noticed that the spatial layout of items in Hobbins' plan were approximate and the location of features, such as the tents, had no readily definable archaeological signature and therefore could not be accurately relocated. Figure 3 shows the camp's features spread across a wide zone; however GIS based mapping (Figure 4) shows the primary site features were actually aligned North to South.

Archaeological recording of the structural remains (Figure 4) provides evidence for the deliberately positioning of buildings; the layout of the camp was planned with the intention of preventing detection by the Japanese. The alignment of all buildings on a north to south axis would have presented a minimum view corridor; a single row of buildings when viewed from a northern airborne aspect. The station diary (Fenton 2000) records that three separate visits by camouflage experts occurred between 1942 and 1943, with a re-arrangement of the camp for camouflage purposes in December 1942. Additionally, all of 105 RDF's infrastructure and buildings were constructed beneath the tree canopy, rather than in the open area adjacent to the Charles Point lighthouse (the lighthouse location contained pre-poured concrete bases, remnants of the former lighthouse buildings, which could have been reused by 105 RDF).

Ammunition was found across the site, but appears to be concentrated within the area of the Gunyah and possible location of the tents. The station diary provides details of a number of occasions when defence and weapons training was provided for the men of 105 RDF. The concentration of UXO within a cleared zone (Figure 4) possibly indicates the location of this training.

Finally, there are a number of weapons pits located across the wider site (Figure 4). It is suggested that small dug-outs had been excavated for use during the Japanese air raids. However, the station diary notes that the men of 105 RDF valiantly remained at their posts during the air raids.

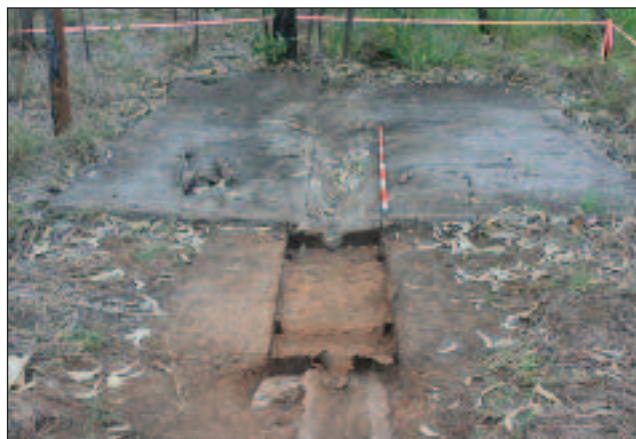
- Kitchen building (concrete slab D) – a square concrete slab (3.9 m by 3.1 m) with a central drainage channel, which flowed south into a grey water system. The function of the slab is suggested to be the kitchen, where food preparation benches (with cut in half 44 gallon drums) would have been set over the drain (Figure 5);

Figure 5: Kitchen slab and grey water system (T. Owen).

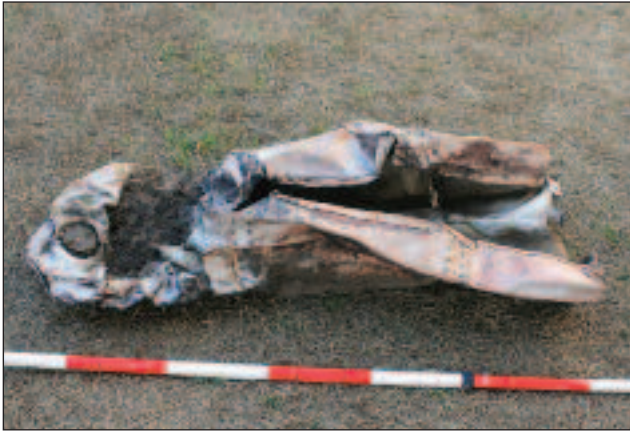
- RAN metal door sign and a metal tag – RAN door sign was found on the mess slab, the metal tag was stamped "James Tombs, Birmingham, England"; and
- A fuel 'drop tank' (Figure 7) and a cylinder block both from a Japanese Zero plane – fuel tanks were dumped by the Japanese prior to the commencement of bombing runs. These frequently washed up on Darwin's beaches and were used by the men of 105 RDF as canoes enabling them to paddle around the bay.

Figure 7: Crumpled drop tank from a Japanese zero (T. Owen).
