Ross Bridge Tasmania

Studies in Historical Archaeology
Number three

ROSS BRIDGE, TASMANIA

Ross Bridge : The Excavation

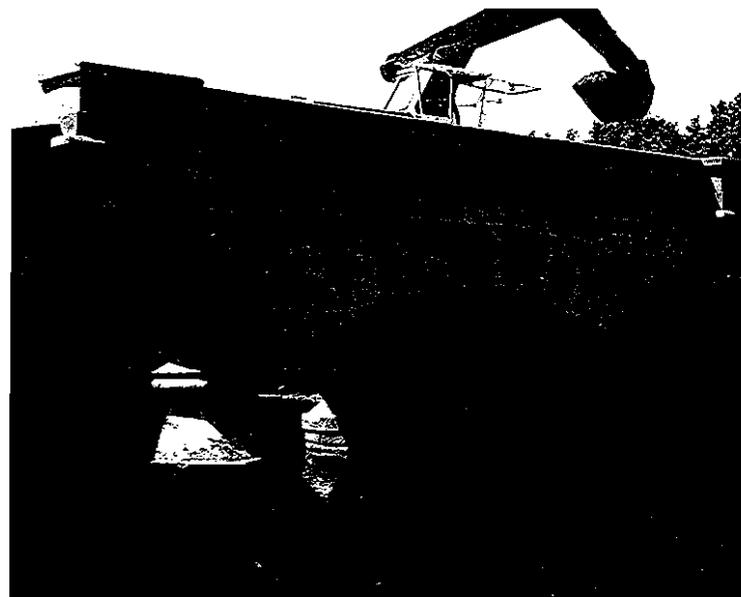
2. North-eastern arch. Note inscription to Captain William Turner.

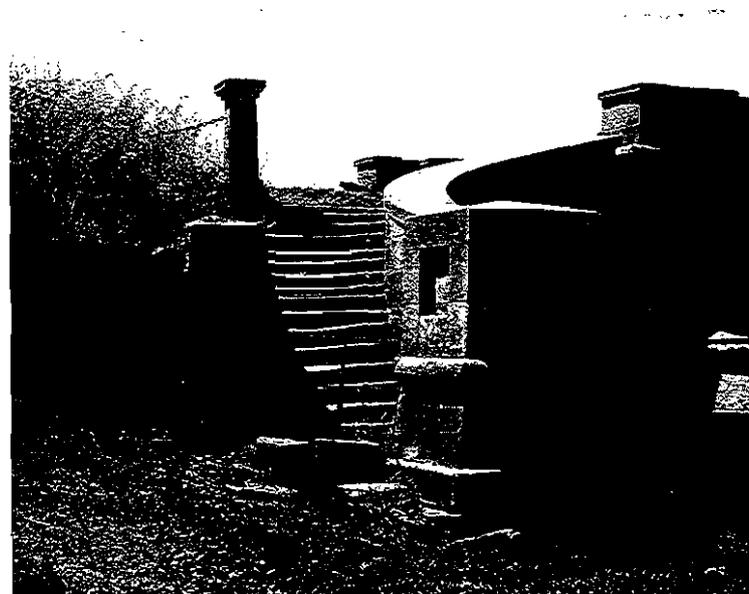
2. Stone steps and bannister curving to the river bank on the south-west corner.

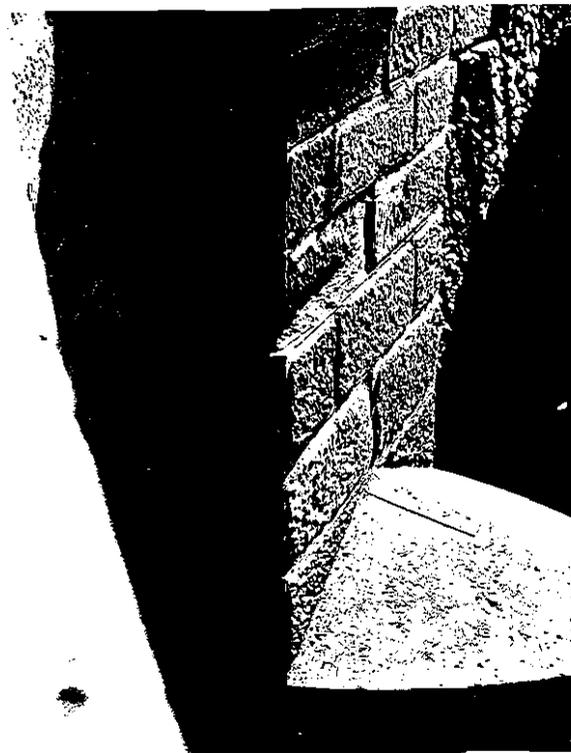
North-east pier. Note the weathering caused by water seepage. These stones have now been successfully replaced.

The main danger to the bridge was water seepage through the stonework. For some years local residents had noticed this seepage during wet weather. It had apparently caused much of the deterioration of the masonry, especially on the north-east pier (pl. 4.1). The local bodies concerned were to be responsible for the replacement of much of this stonework while the PWD undertook to waterproof the bridge surface in an effort to prevent future damage in this way. The Ross Bridge Restoration Committee has remained responsible for the work throughout.

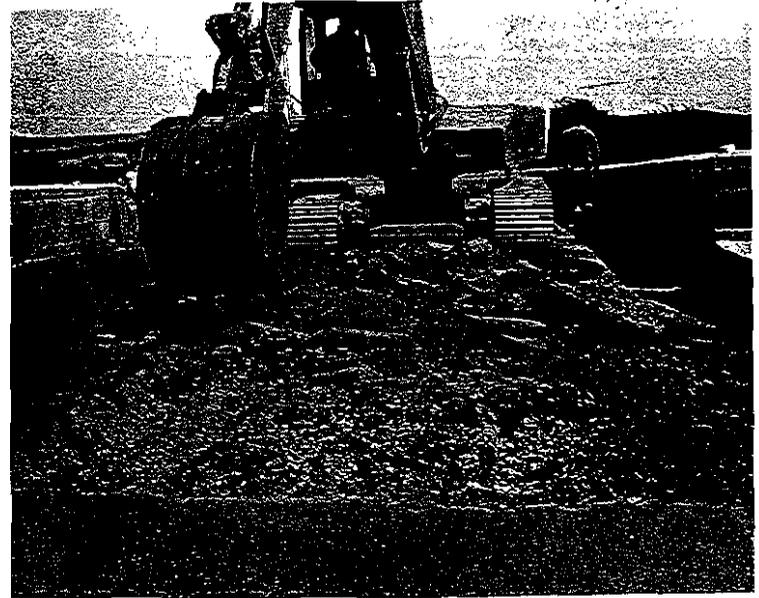
1. Removal of bitumen by track laying excavator.

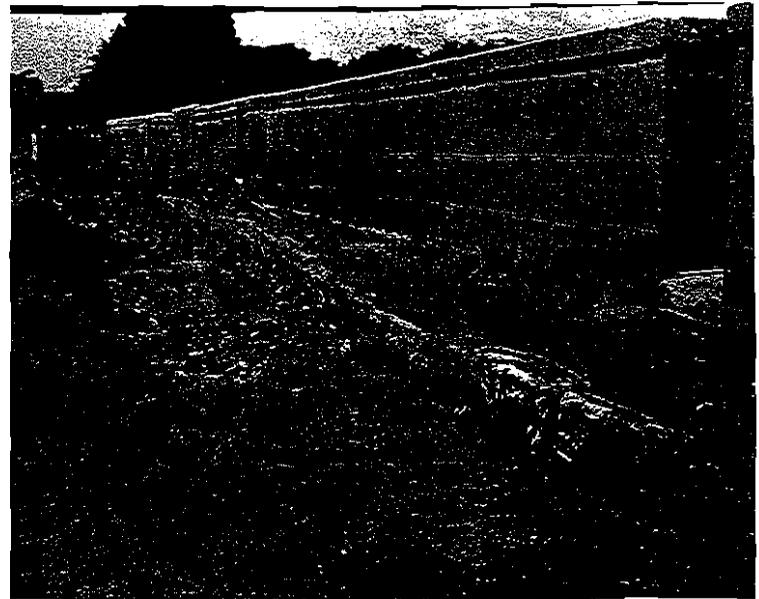
2. Kerbstones emerging after removal of bitumen.

Exposed at the same time were two rows of kerbstones dividing the carriageway from a footpath on either side of the bridge. (pl. 6.2) The kerbstones are of sandstone and have a rounded upper edge. Their lengths are irregular; their heights are fairly standard at around 460 mm. Three of the four end kerbstones were dummy bollards; the fourth was missing. It probably disappeared when that end of the bridge was washed out during a flood.

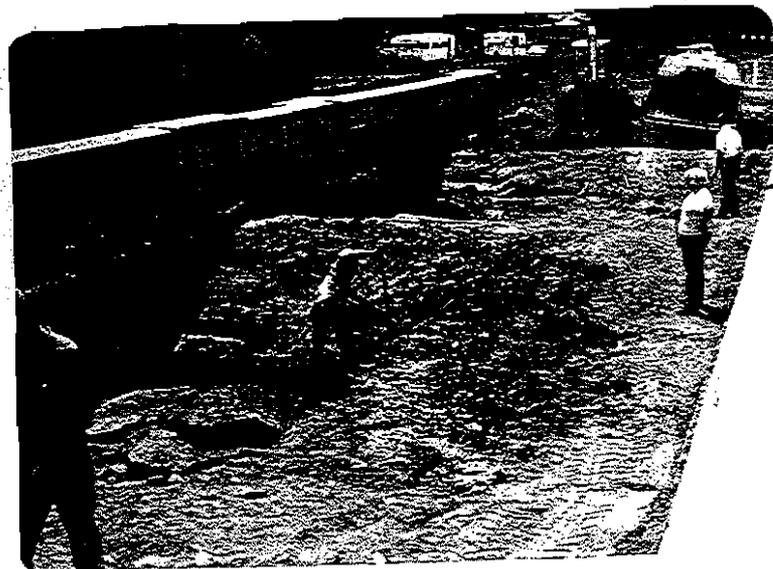
1. Removing the filling material on the north side of the carriageway.

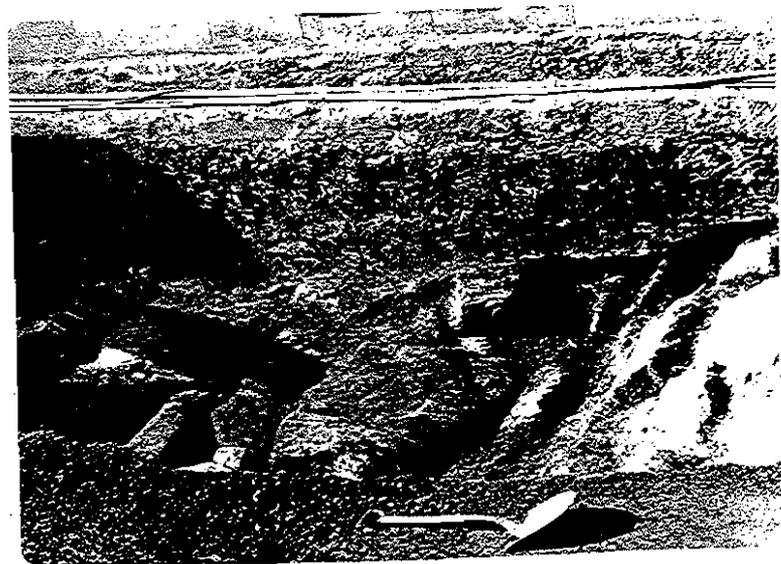
2. Floor of large stone blocks between the central and western arches (south side).

In the area between the central and western arches there was, as in other areas, a mixed deposit of brown earth and crushed stone gravel. Below this was a quite shallow deposit of quarry waste material but the major filler here, unlike other areas, was dense black clay, (pl.8.1). The quantities of this material found here were unlike those anywhere else on the bridge. The clay was also damp, becoming quite wet beneath the footpath area. Its removal was therefore very necessary, since there is little point in waterproofing over a waterlogged deposit.

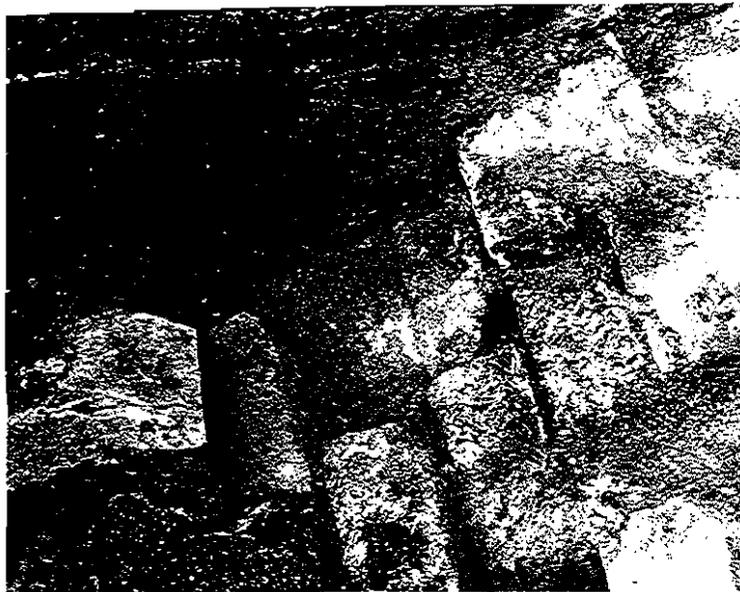
1. Stone blocks forming the west side of the central arch (N). Note the depth of the black clay filling.

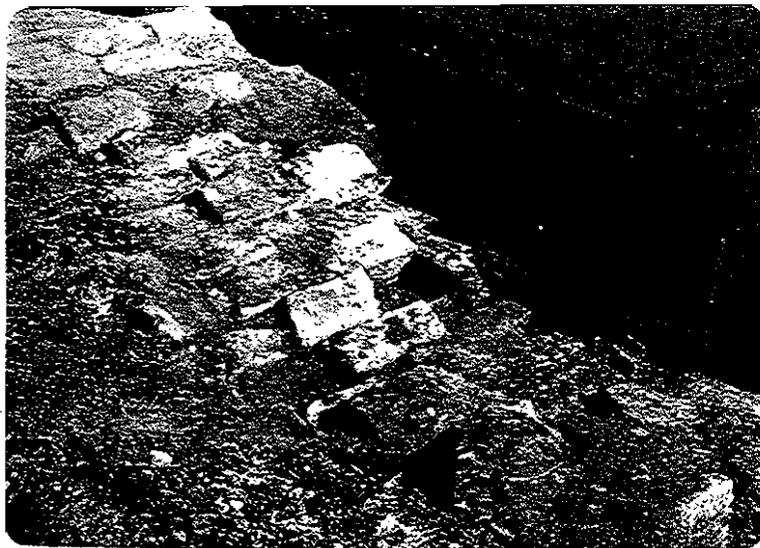
2. Eastern side of western arch (N) and adjoining floor.

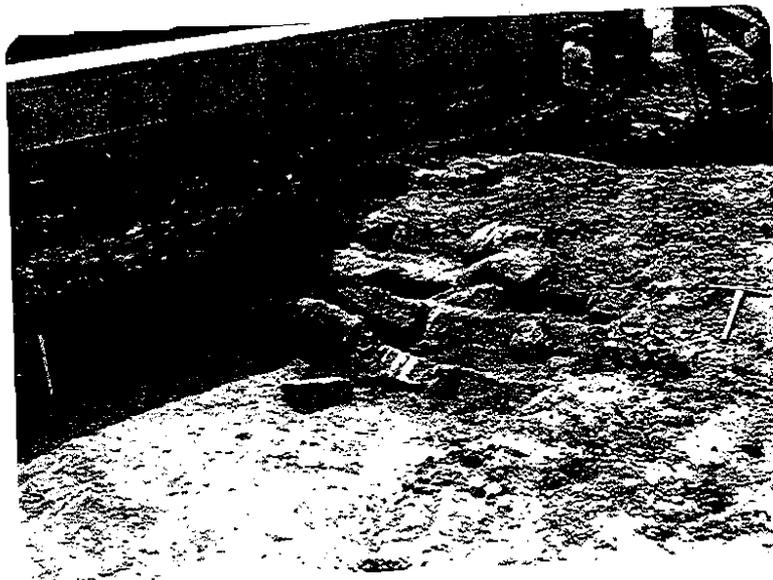
1. Eastern arch (N) and mortar flooring between it and the central arch.

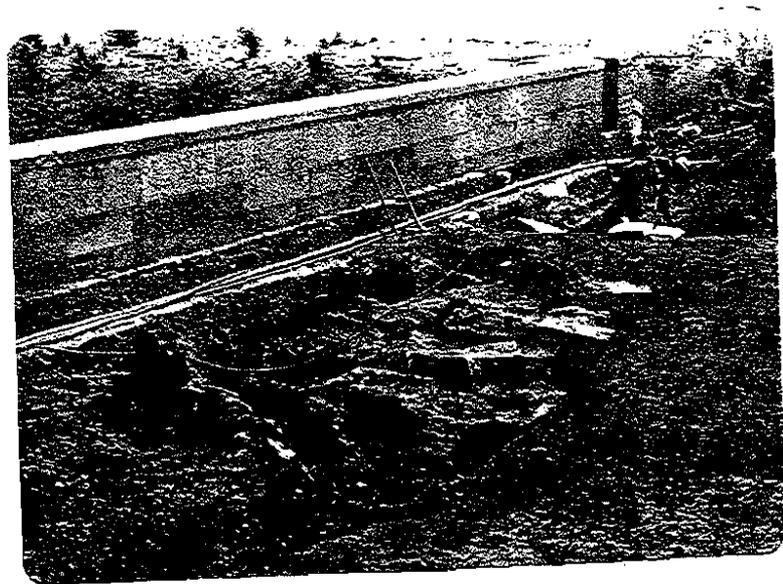
2. Western arch (S). Note the refilling of one area with ironstone gravel and cement.

The area from the western arch to the end of the bridge follows much the same pattern but earlier road reconstruction had altered it somewhat. The destruction of part of the road surface due to flooding some years previously had resulted in the addition of ironstone gravel to the earlier filling materials. Black clay, as elsewhere on the bridge, lines the walls and covers the arch. Sandy quarry waste material, the basic filler, is found below the ironstone gravel and on top of the series of mortar floors. (pl.10.1; 11.1). The ironstone gravel is found immediately below the bitumen and to a depth of approximately 400 mm. below the kerbstones. Any kerbstones disturbed during its addition, and these were only in the south-west area, were replaced on a bed of fine

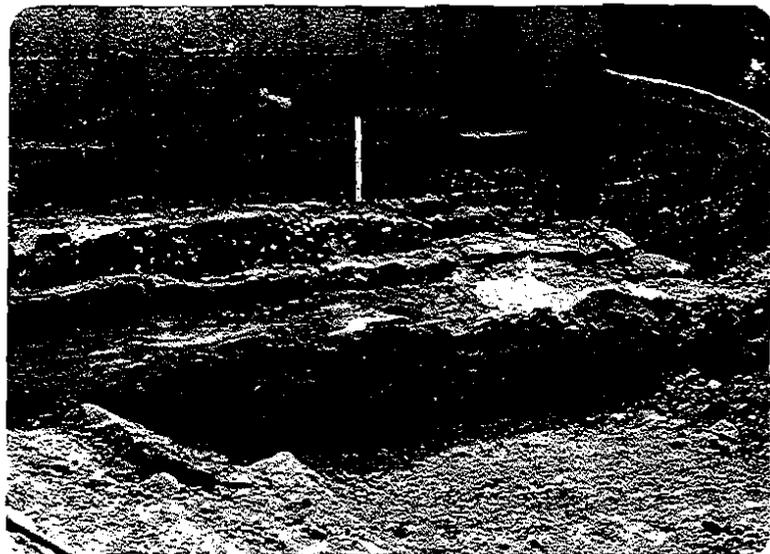
1. North-east end of bridge. Note the series of buttresses taking the weight of the arch.

The reconstruction work done on Ross Bridge enabled many points of construction detail to be noted. In an arched structure the central arches lean on those next to them; with Ross Bridge, therefore, the weight of the central arch is taken by those arches on either side. The end arches, however, have only one support; their weight is taken by the bridge wall. Photographs (pl.10.1,2; 11.1) illustrate how this is achieved. The arch is built into the bridge wall by a series of buttresses of different heights and different lengths.

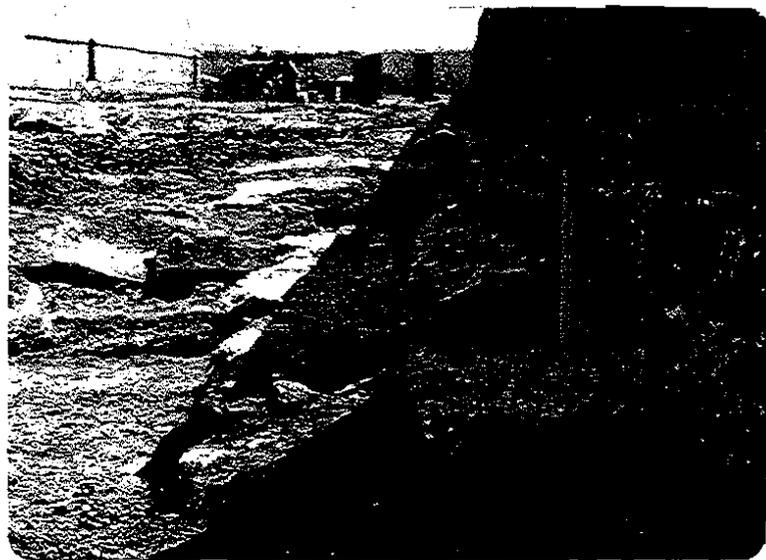
2. North-east end of bridge looking along buttresses to the eastern arch. Each buttress starts from a different level of the arch.

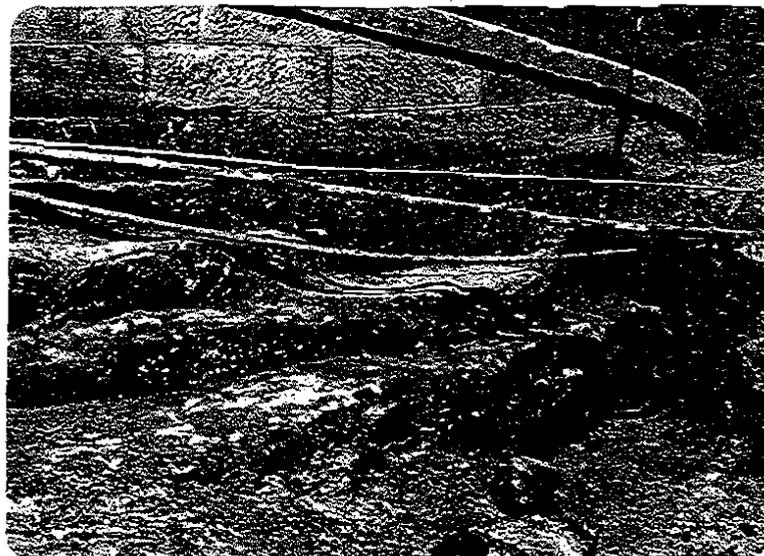
1. Buttressing on south-west end of the bridge curving around the bannister.

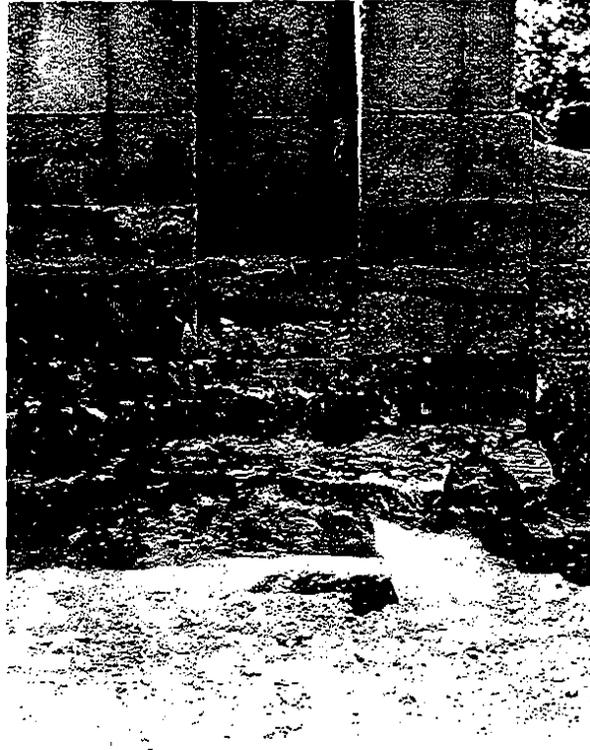
Eastern pedestrian refuge (north side) and buttresses.
The stone is sitting on a layer of brown earth over
a thicker layer of mortar.

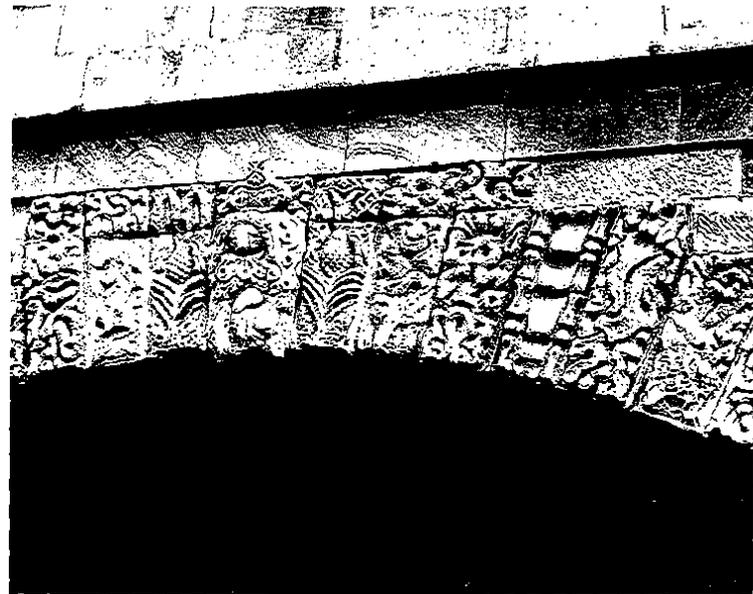
1. Voussoirs (arch-stones) on the north-east arch. Note how the lengths of the middle seven stones of this arch were underestimated and extra small blocks had to be made.

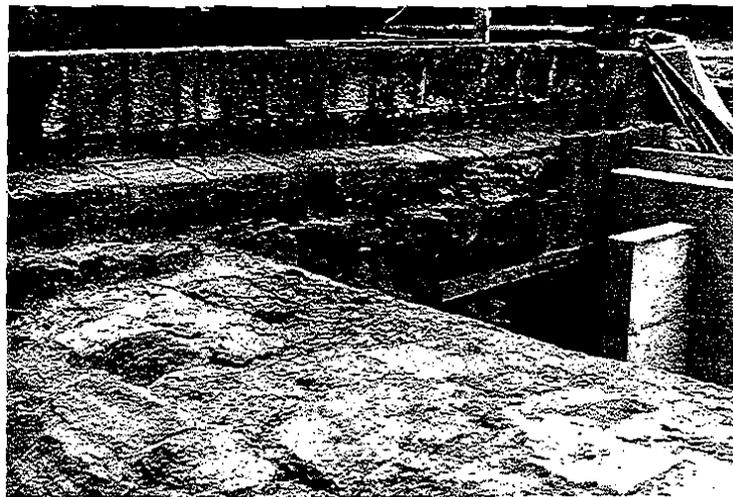
2. Lennox Bridge, Lapstone N.S.W. Note the recently exposed footpath, the top of the stone arch, and the beginnings of the concrete bridge being built inside this 1832 structure.

To enable the road across Lapstone Bridge to be opened to traffic again, and to ensure the preservation and stability of this unique bridge, it was decided to build a concrete bridge inside and over the stone one, leaving the stone untouched. In the right of the photograph is one concrete wall; there is another on the opposite side of the arch. The filling material was then to be replaced, a concrete top put down, and the road relaid.

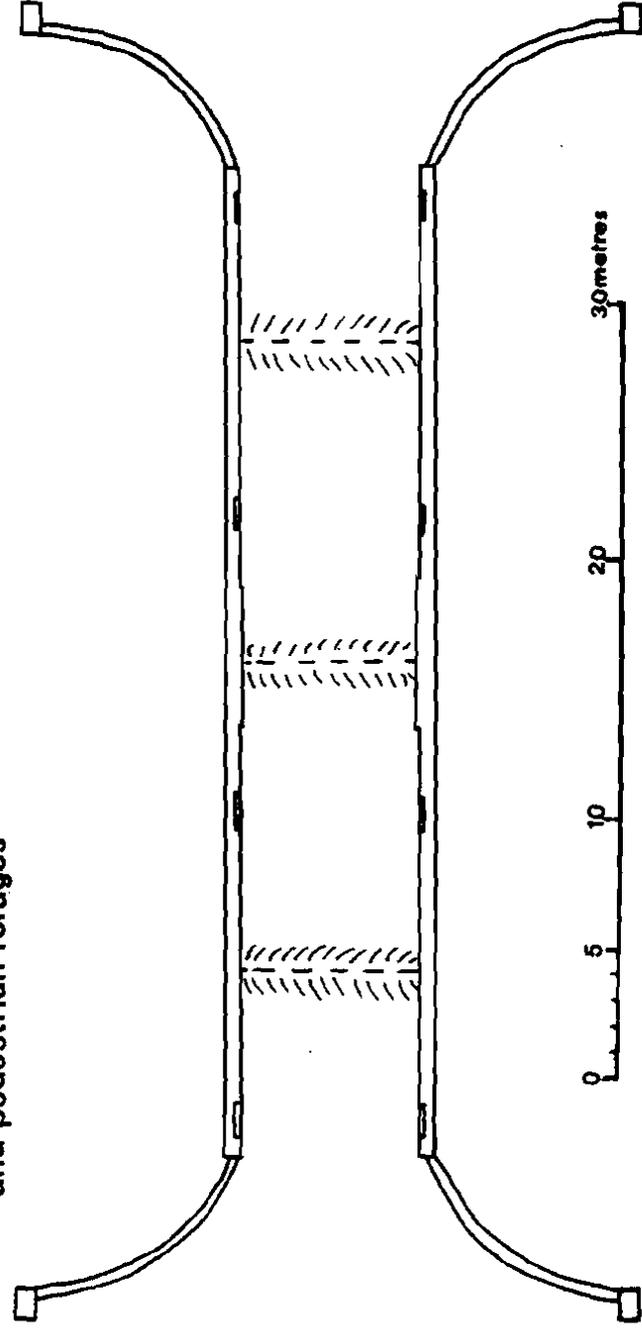
PLAN 3

Plan of Bridge showing walls, arch tops, balustrades and pedestrian refuges

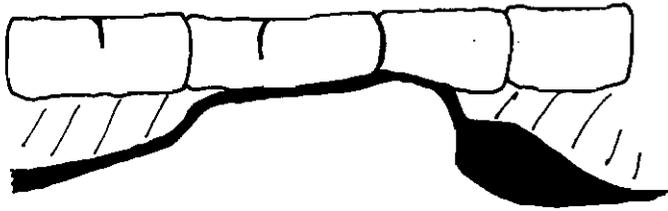
Relationship between the kerbstones and the top of the western arch (North)
